## HERITAGE SERVICES AT WWA

# ENERGY CONSERVATION IN HISTORIC BUILDINGS

# SPECIALIST CONSERVATION TO PRESERVE HISTORIC STRUCTURE AND CHARACTER

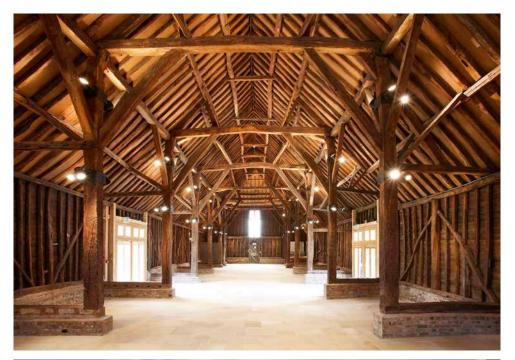
Above Images: Show the careful extent of repair detailing necessary to satisfy conservation officers to achieve listed building consent. A thorough set of drawings pays dividends on site, with the scope of works so clearly defined, it allows tight control over budget and cost.

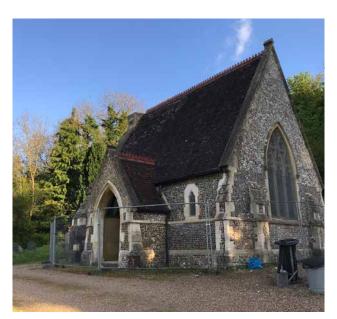
Above Image: 1868 Non-Conformist Chapel.

This small 1868 Grade II listed, Non-Conformist Chapel at Fairmile Cemetery was redundant and in poor condition prior to our appointment. This was an unusual commission in that our client had no idea what could be made of the building. Initially instructed by Henley Town Council to investigate possible alternative uses, WWA suggested that the chapel could be converted into a Columbarium as a cost-effective way to secure a new use via public subscription – i.e. the renting of niches in which to store funeral urns.

The first part of our commission was to prepare a specification for the repair of the fabric of the building. Rainwater had entered the structure of the building over many years due to neglect. Dampness was rife therefore making it essential to rectify these defects and allow time for the building to dry out completely.

Most of the internal render of the chapel was in a dense sand/cement render. Being impervious, it was retaining moisture from damaged roofs and rainwater goods and in some areas had already separated from the brick backing. Large sections of render had fallen away at both low and high levels.
